# Amalgam and Mercury in the Dental Setting and the Efficiency of Amalgam Separators

Master of Science Thesis, Environmental Science Programme, 2007

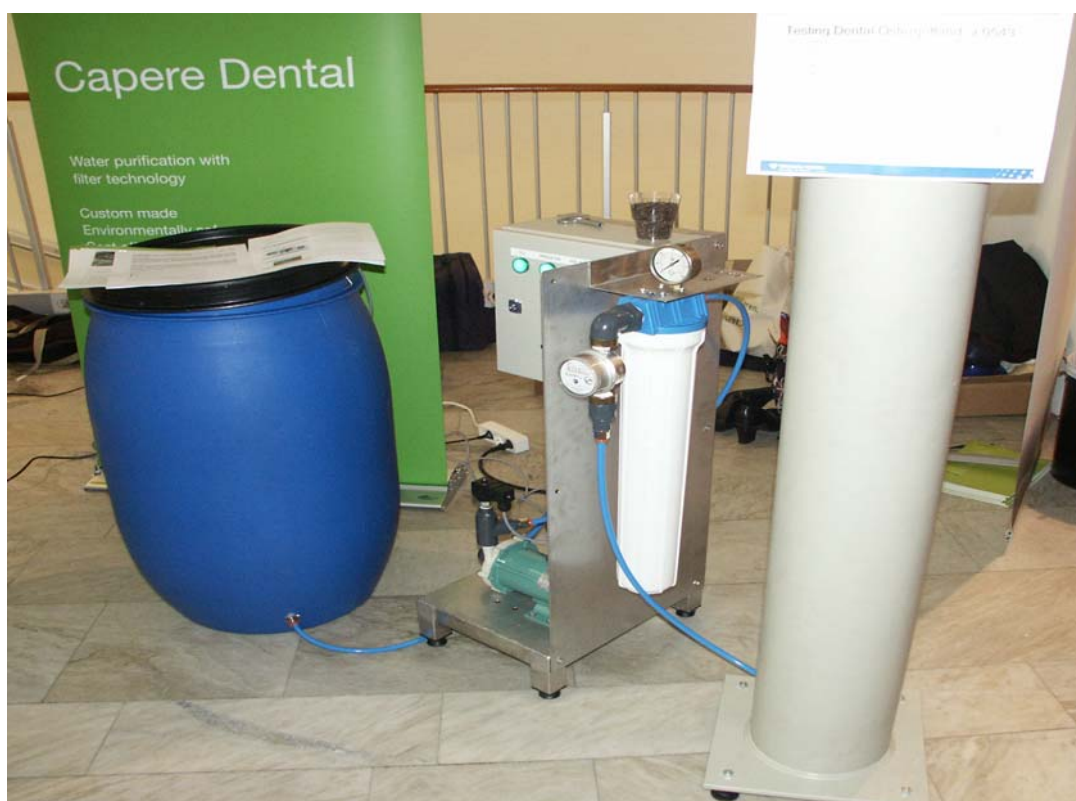
In Sweden there has been a new improvement in amalgam separators and it is called Capere Dental (Tekniska Verken, Linköping). This is a way of getting to the very fine amalgam particles and the ionic mercury and other metals in the effluent after the particle separator and before it goes into the sewer. This unit consists of finely shredded pine tree bark (5-7 mm pieces) with a coating of a chelator, that is sensitive to ionized metals, but not to calcium or magnesium ions. The effluent which has passed the amalgam separator is then going through a cotton filter, with a mesh size 5-10 micron, before it is finally reaches the bottom of the circular bark container and is pushed upwards through the bark like in a coffee percolator. The cotton filter and the bark catches the minute particles and the metal ions and together they end up cleaning the effluent of 95-99% of not just the mercury, but also the silver, zinc, copper and tin from the amalgam as well as other metals when crowns, bridges and other prosthetic dental work are replaced. The first large-scale working unit of this kind was installed in a clinic in Norrköping in 2004, after a trial run at a smaller clinic in Linköping, where it was shown to be very effective. Since the results have been very promising, other units have been installed in a few more clinics in the region and more installations are on the way (Berggren, 2004, 2005 and 2006; FTV-Östergötland, 2006).

**Fig.2 Capere Dental Separating Unit, cotton filter to the right, bark container on the left, photo by the author.**

The Capere unit is a promising tool to add to the regular amalgam separator in order to prevent the release of the ultra small amalgam particles and the ionic phase of mercury into the effluent from dental facilities, which the regular ISO certified amalgam separators do not seem to be able to do at present. Further improvement of the Capere unit, where it would replace the regular amalgam separator is under consideration.

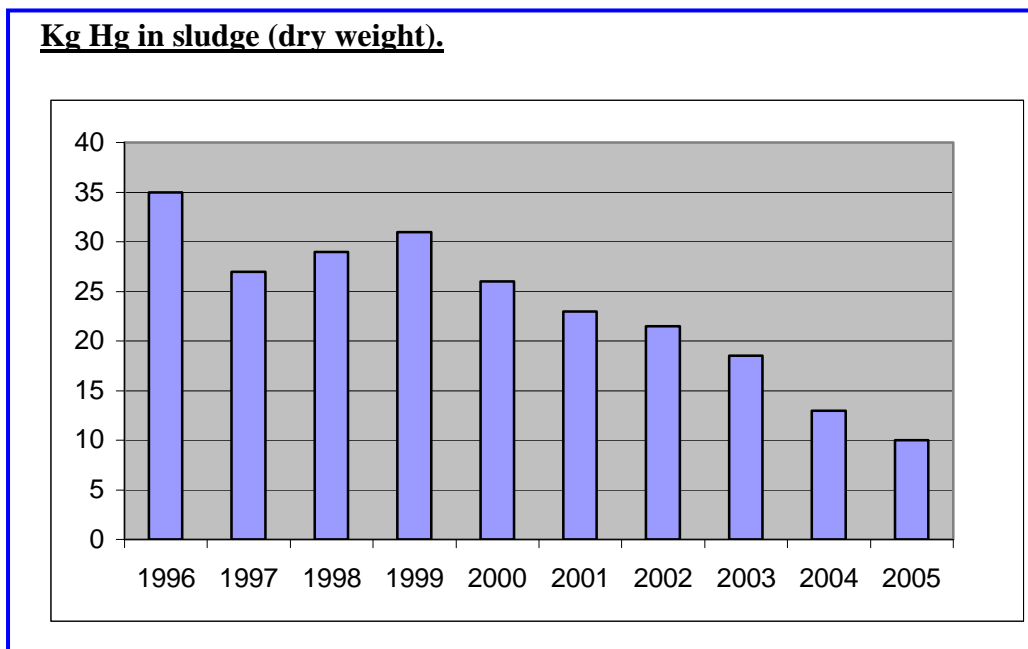
**Fig 4** depicts the amount of mercury in the sludge, dry weight, from 1996-2005 at Henriksdal wastewater treatment plant.

Stockholm Water AB has been having an active campaign to reduce the mercury in the waste water pipes in Stockholm since 1996, by either cleaning them but more often replacing them. In-between 1975-80 the sludge contained 1500 kg Hg/year, and it decreased to 85 kg during the period 1981-90. A further decrease was seen during the years 1991-96 from 56 to 36 kg/year (Sörme, 2003). The peak of 31 kg Hg in 1999 came when closed down old school clinics had their pipes cleaned out. This was done under the supervision of Stockholm Water AB, but some released mercury still ended up in the wastewater treatment plant at Henriksdal. Stockholm Water AB hopes to have the level of mercury down to 5 kg or less by the end of 2006.

**Fig 4. Hg in sludge at Henriksdal wastewater treatment plant, Stockholm.**

The amount of mercury in the sludge at Henriksdal wastewater treatment plant has decreased considerably since the 1970's (Sörme, 2003) and the introduction of amalgam separators. The decreased use of mercury not only in dentistry but also in other applications and instruments has helped in lowering the load of mercury in the sludge. As seen in Fig 4 the drive by Stockholm Water AB to clean out and/or replace old pipes in the Stockholm region clogged with amalgam and mercury has been very effective. The other initiative was to check the efficiency and working order of the amalgam separators, see Table 3, and it was very interesting to find that many separators, about 22%, were not acceptable (older, less efficient and/or discontinued models), and 16% of the separators were not working correctly (see under malfunctions, below).

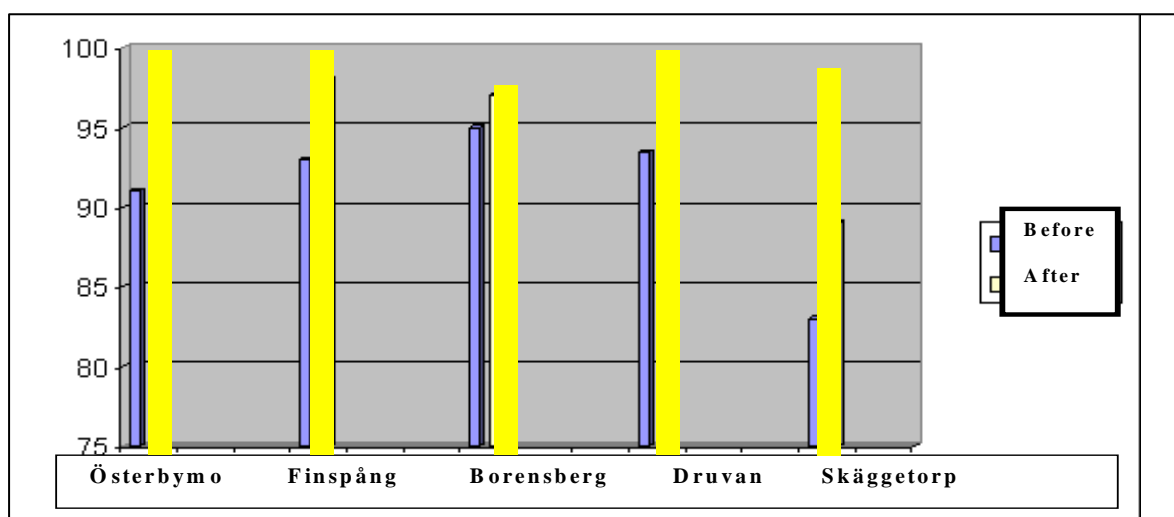
The Capere Unit can on the average trap up to 277g of ionized Hg before getting saturated, which is equal to 2.1mg Hg/chair/day (ISO 11143 and the EU directive limits the amount to < 2.5 mg Hg/chair/day in the effluent). The pine bark is changed every 6 months and heating it, or lowering the pH of the bark to 1-2, retrieves the metals trapped in it. The cotton filter is also changed every 6 months and cleansed; the metal residue is recovered and recycled.

**Fig 5. Before and after the insertion of the Capere filter.**

The addition of the Capere unit to an amalgam separator as done in Östergötland, the removal efficiency of amalgam and mercury from the effluent was shown to increase considerably and with this environmentally friendly and cheap method. The bark is a bi-product from the forest industry and would be burnt if not used for this purpose.

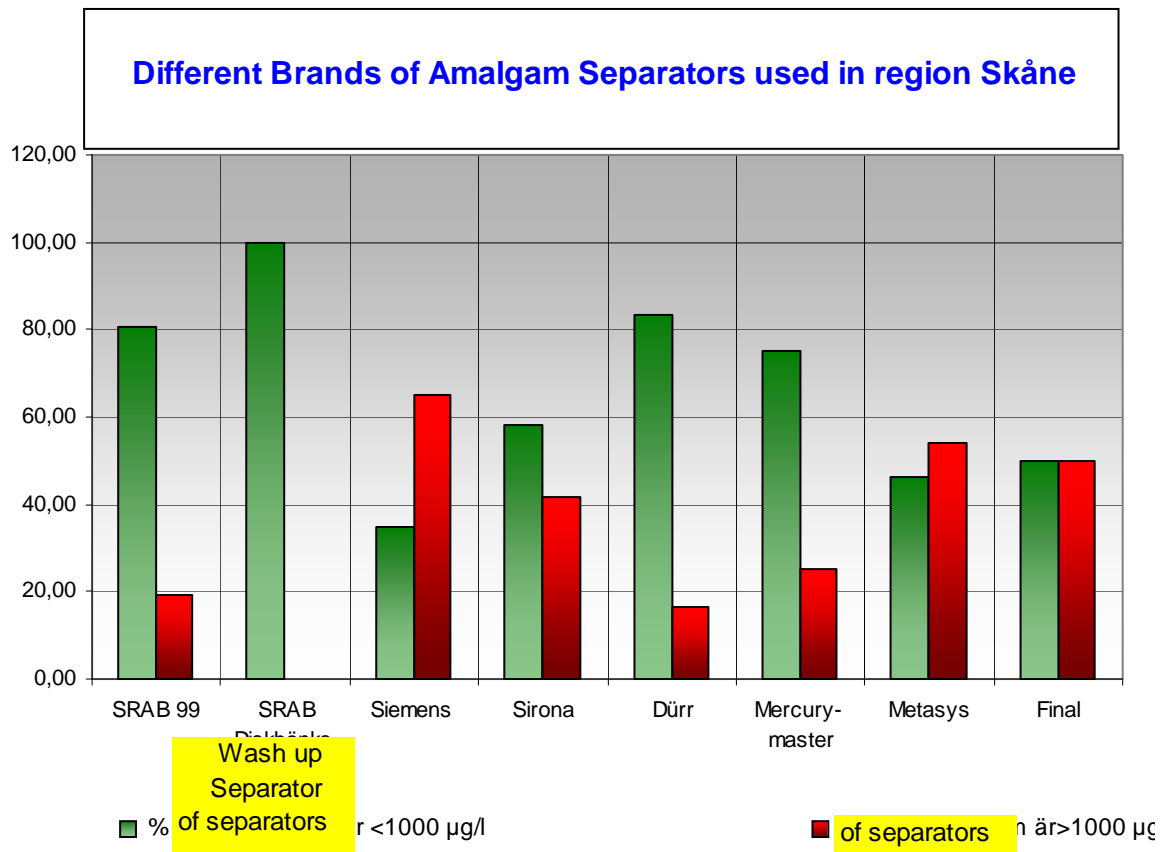
As can be seen in fig 6, two separators of older discontinued models (one SRAB 95 and one Stena-Scanfors) were excluded from the figure. The SRAB wash up area separator was 100% effective, which is to be expected since it deals with washing instruments contaminated with mercury/amalgam and the water from the sink goes straight into the separator and can sediment out. Of the dry centrifugal separators the Dürr had the highest number of separators that emitted less than 1 mg Hg/l/chair/year, 83% as seen by the green staple, but at the same time 17% of their separators emitted more than 1 mg Hg/l/chair/year, the red staple. There is no data as to which brands were in which clinic, or if they were of centrifugal or sedimentary type. Of the dry sedimentation type of separators the SRAB 99 had 81% that emitted less than 1 mg Hg/l/chair/year, but also here you had a group of 19% separators that released Hg above this level. Still all in all, 25% of the separators had outgoing levels of Hg higher than 1 mg Hg/l and chair, which is above the acceptable limit (SRAB amalgam separator protocol, 2004, based on the ISO-11143 standard and the EU directive, 84/156/EEC). Siemens and Metasys had both more separators that were releasing more Hg than the acceptable limit than below, 65% vs. 35% for Siemens and 46% vs. 54% for Metasys, while the Final separators had just as many above as below the acceptable limit.

Fig6. depicts mercury in the effluent from different clinics using different brands of amalgam separator
