Environmental regulatory failure and metal contamination at the Giap Lai Pyrite mine, Northern Vietnam

N. Håkan Tarras-Wahlberg and Lan T. Nguyen

N. Håkan Tarras-Wahlberg and Lan T. Nguyen, Environmental regulatory failure and metal contamination at the Giap Lai Pyrite mine, Northern Vietnam, 2008, Journal of Environmental Management, (86), 4, 712-720.

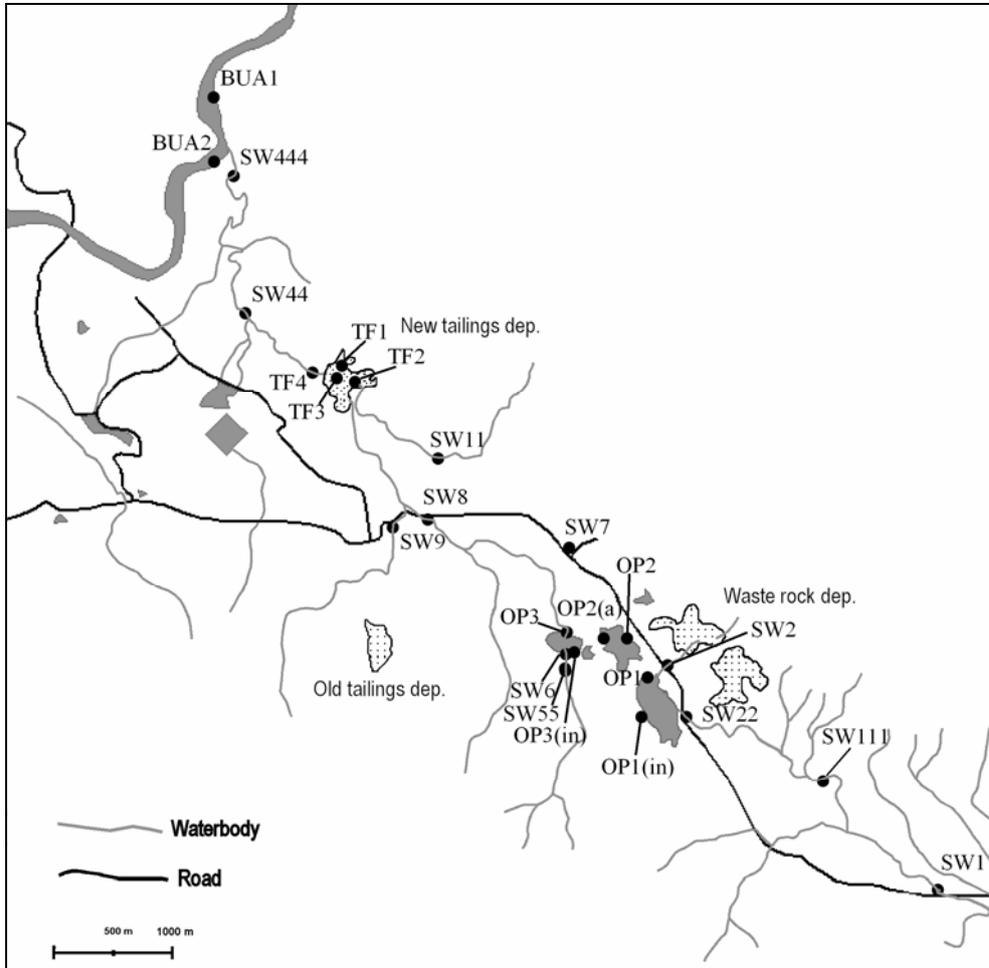
Figure 2. Map showing the location of all surface water and sediment sampling sites in the Giap Lai mining area.

The mining area is located on a regional water divide, and is drained by two small streams (Figure 2). These are the Thanh Son, which empties into the Bua River (6.5 km to the NW), and the Thanh Thuy which empties into the Da River (7 km to the SE). The Thanh Son's discharge varies between 10 and 100 ls^{-1} , whereas the Thanh Thuy's discharge varies between 5 and 350 ls^{-1} . The Bua River carries 7-50 $\text{m}^3\text{sec}^{-1}$, whereas

The severity of environmental impacts was investigated by collecting samples of surface waters, and stream sediments at selected sites in and around the mining area (Figure 2). Surface water was taken during all sampling campaigns. Stream sediment sampling was collected twice (in September 1997 and February 2002).

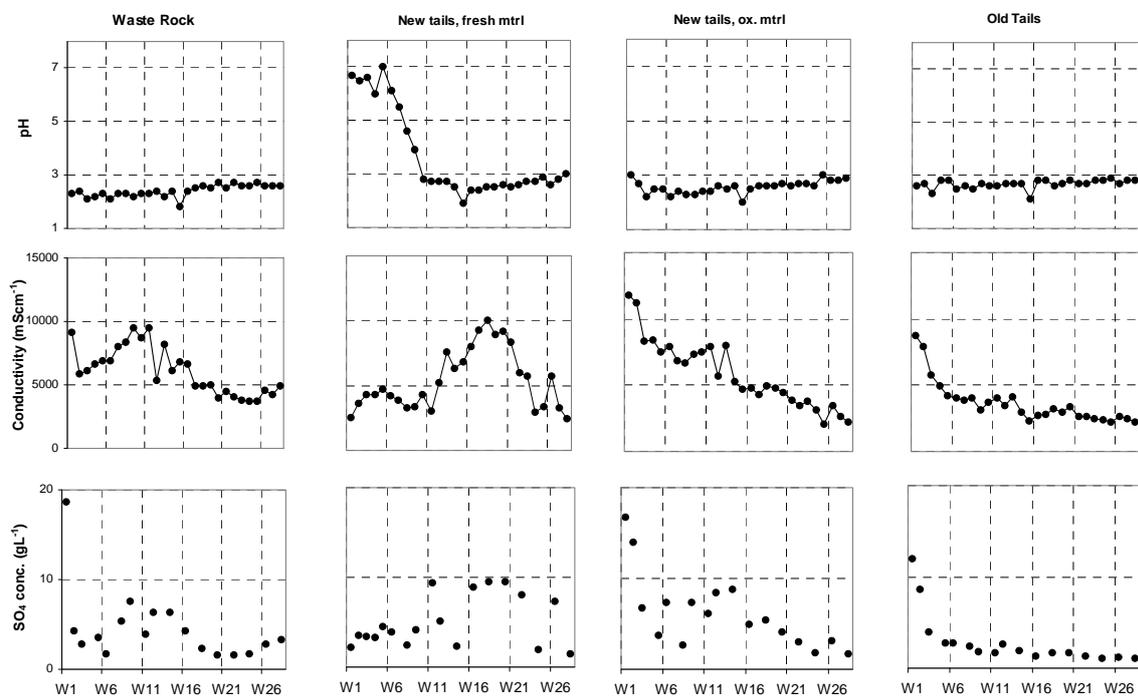
The results of the leaching tests are illustrated in time series in Figure 3. The progressive leaching of a fresh sample from the new tailings impoundment (new tails) shows that this material is initially well buffered as the pH remains high until week 6. However, after week 6 the pH falls dramatically to stabilise at between 2 and 3. Simultaneously, there is an increase in the conductivity of the leachate coupled with a concomitant increase in sulphate levels. This provides good evidence that, in spite of initially being well buffered, this material will eventually generate ARD.

Figure 3. Graphs showing results of the leaching experiments

The other three samples, representing waste rock, material from the old tailings impoundment, and already oxidised parts of the new tailings impoundment have similar leaching characteristics. Unlike the new tails, pH values are low already from the onset, equilibrated at around 3. The pH remained stable through the duration of the experiment. Conductivity readings and sulphate concentrations gradually decrease with

time, showing how the easily leachable sulphide minerals become progressively scarcer. Thus, it is suggested that waste rock and tailings material will generate considerable amounts of ARD, and that this may occur over a long periods of time. These conclusions are corroborated by the results of the field sampling and analysis (see below).

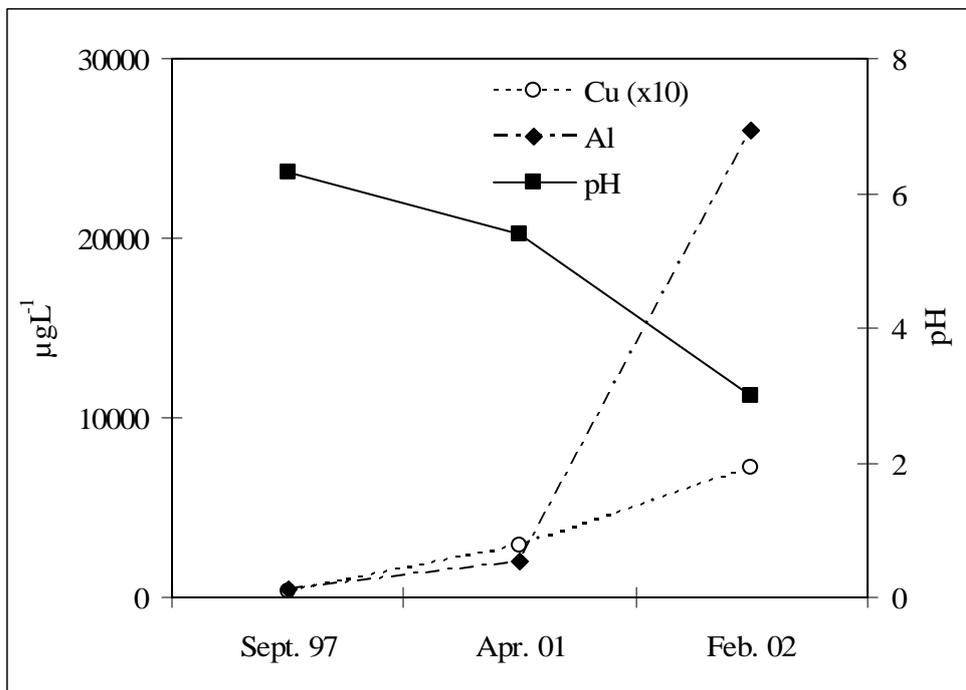
Figure 4. Graph showing pH and the concentrations of Cu and Al at a site (TF4) downstream of the new tailings deposit.

1997, 2001 and 2002 suggests that metal leaching is becoming progressively more severe with time (Figure 4). The pH of this seepage has decreased dramatically during this period, from just below neutral in 1997 when operations were still ongoing (6.3), to strongly acidic in 2001 and 2002 (5.4 and 3.0, respectively). In the 2002 investigation, the seepage water contained high concentrations of metals that are toxic to both humans and to aquatic life. The concentrations are, however, relatively rapidly diluted downstream (Figure 5). Thus, the metal concentrations at SW444, a bit more than one kilometre downstream of the new tailings impoundment, although still noticeably elevated, no longer exceed U.S EPA water quality standards. Further, the effect on the Bua River (c.f. samples Bua 1 and Bua 2) appears to be negligible (Figure 5). Similarly, water samples collected downstream of the waste rock deposits have low pH and elevated concentrations of Cd, Cu, Ni, Pb and Zn (Table 2). However, low metal concentrations in samples taken some distance downstream (e.g. SW111 and SW1) suggest that significant impacts are restricted to an area less than a few kilometres downstream of the waste rock deposits.

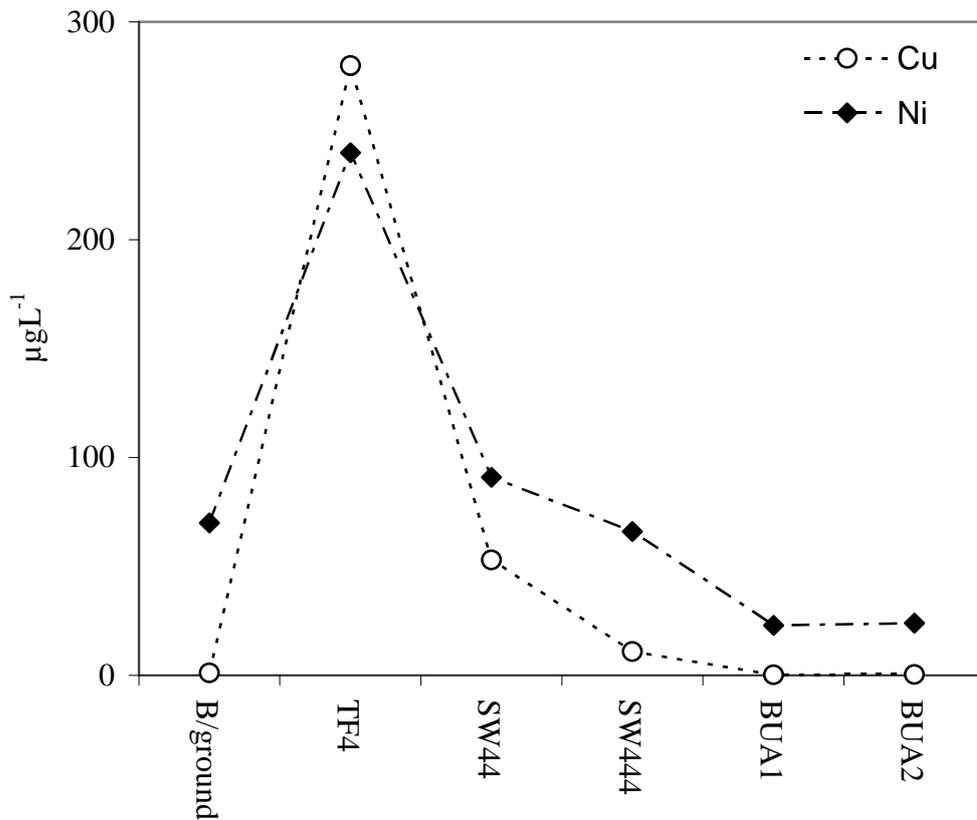
Figure 5. *Cu and Ni concentrations in surface water affected by drainage from the new tailings facility. The sampling locations are plotted in downstream direction, left to right. Samples taken in April 2001.*

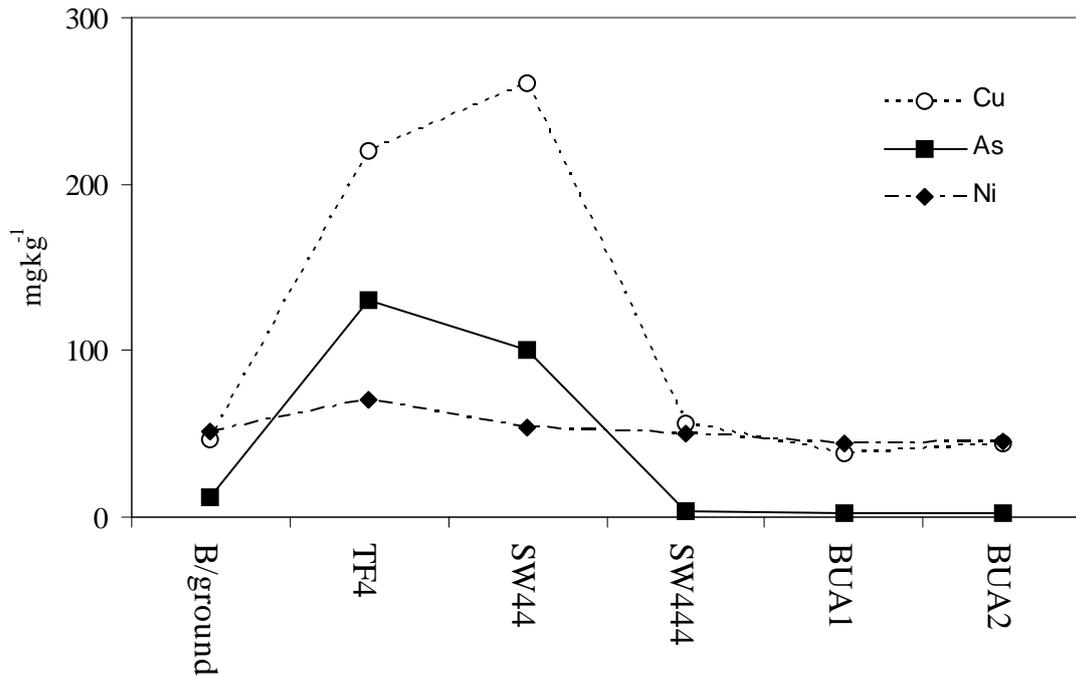
Figure 6. Cu, Ni and As concentrations in sediments downstream the new tailings facility. Sampling locations are plotted in downstream direction, left to right.

encountered at this site are high in comparison to the world average for metal concentrations in sediments (Förstner and Wittman, 1983). Downstream of the contamination sources, the metal levels are elevated compared to background. The elevations are however modest, and there are only a small number of cases where metal levels exceed U.S EPA standards. Those highest concentrations are found at the sites TF4 and SW44 which are both situated downstream of the new tailings facility. The impacts on sediment quality rapidly become less serious further downstream. This is illustrated by two samples taken from the Bua river where the sample taken upstream of the influence of the Giap Lai mining area is near identical to the one taken further downstream (Figure 6).
