Chronic anterior tibial stress fractures in athletes: No crack but intense remodelling.

Jörg Schilcher, Magnus Bernhardsson and Per Aspenberg

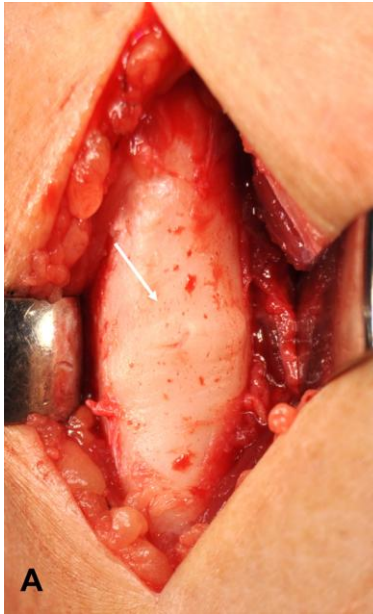
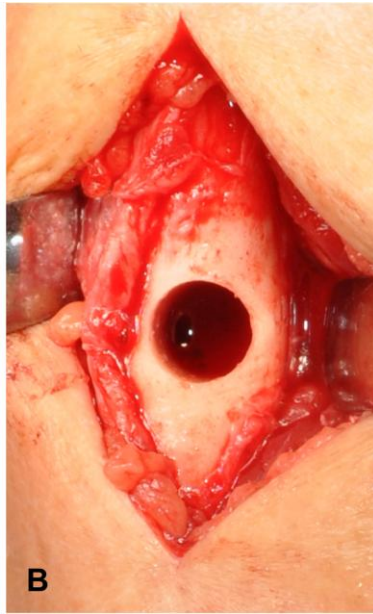
Figure 1. The anterior tibial shaft exposed intraoperatively (A). The arrow indicates an area of a cortical crevice with surrounding periosteal callus (Case 6). The cortical defect after resection of the biopsy (B).

The fracture line was identified with an image intensifier. A longitudinal skin incision followed by an incision of the crural fascia was made slightly lateral to the anterior margin of the tibia at the level of the fracture line. In the wound, a periosteal callus reaction could be palpated in all cases. After a longitudinal incision of the periosteum, the bony prominence (periosteal callus) could be seen in all cases (Figure 1A). The site was excised with a cylindrical drill (diameter: 7.3 to 9.4 mm) as a cortical full-thickness biopsy under image intensification (Figure 1B). Postoperative weight-bearing was allowed as tolerated.

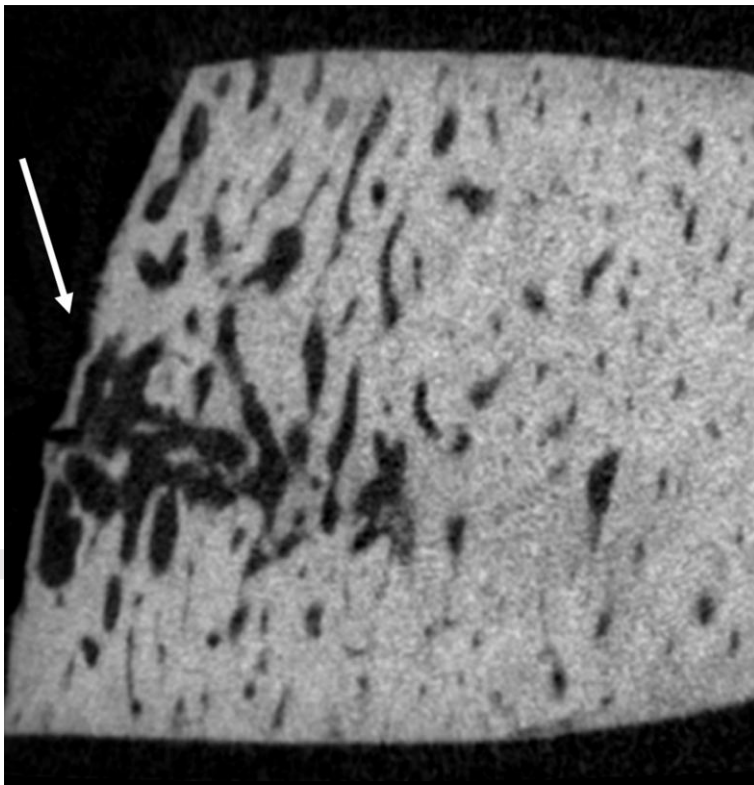
Figure 2. Micro-CT showing areas of increased resorption in the subperiosteal bone (arrow).

The micro-CT sections of the cylindrical specimens did not show a fracture or a fracture crack in any of the cases. Instead, the lesion corresponded to an area in the cortex with wide resorption cavities and an irregular bone structure (Figure 2) corresponding to the histological findings.

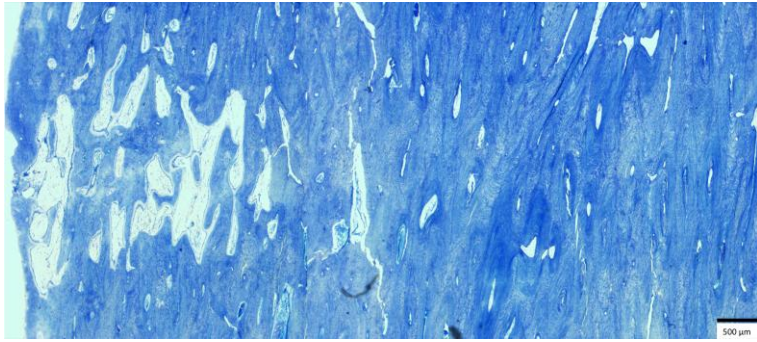
Figure 3. Histological section (toluidine blue) showing increased resorption in the subperiosteal area (to the left) compared to the cortical bone close to the medullary canal (to the right). The picture consists of two superimposed images to cover the whole thickness of the anterior tibial cortex.

The lesion extended roughly halfway from the periosteal to the endosteal surface, meaning that the inner, endosteal half consisted of normal-looking osteonal bone, with a structure clearly in contrast to the lesion (Figure 3).

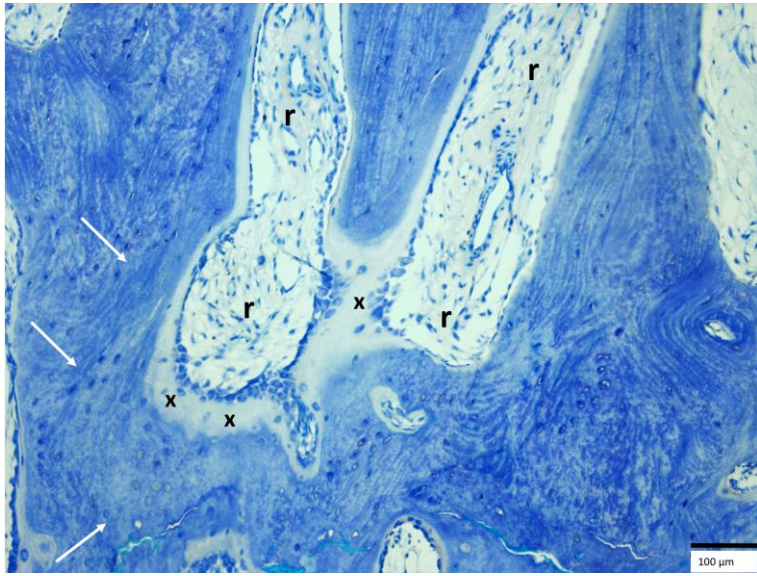
Figure 4. Resorption cavities (r), lined with active osteoblasts surrounded by immature woven bone (arrows) and osteoid (x).

Histology showed a 1-2 mm thick periosteal callus in all cases. The callus was well integrated into the underlying cortical bone. Corresponding to the intracortical changes seen on CT and visual inspection, histology showed changes that can be described as resorption and increased remodelling (four cases) or a crevice (two cases). In the cases with resorption and increased remodelling, the lesion comprised wide resorption lacunae (Figure 3), some of them lined with active osteoblasts (Figure 4), and areas of irregularly structured woven bone.

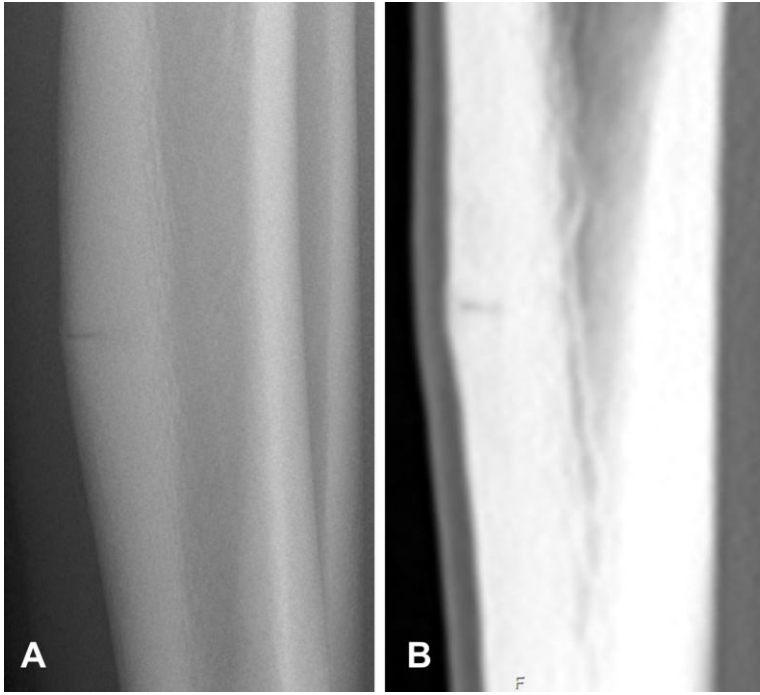
Figure 5 A transverse “fracture line” in the anterior cortex of the tibia on plain radiograph (A) and CT (B) in Case 1.

On plain radiographs or CT reconstructions, all patients showed a horizontal or short oblique putative fracture line (Table, Figure 5). In one patient with available consecutive plain radiographs, this radiolucent line changed in shape between examinations. Initially it appeared as a fracture line. Two months later it appeared as a circular lytic lesion, and 11 months later, it looked like a fracture line again (Figure 6).

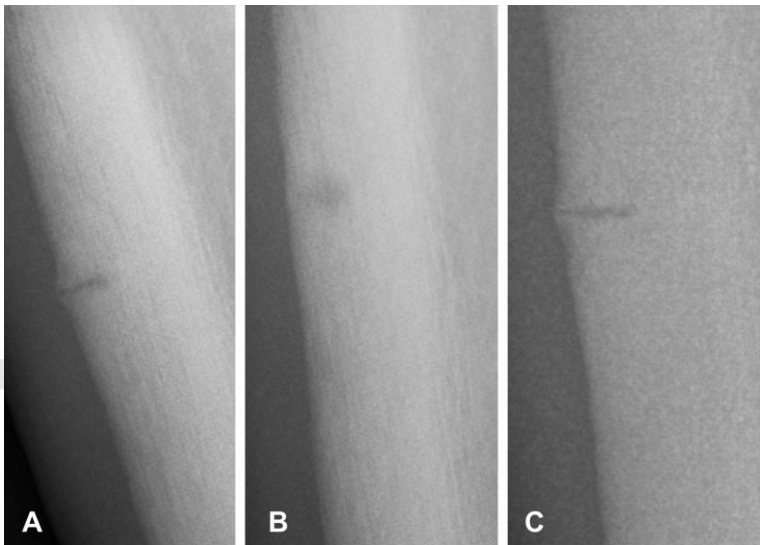
Figure 6. Plain radiograph of a stress fracture showing a transverse “fracture line” (A). Two months later (B) the fracture line was replaced by a circular area of bone resorption. Another 11 months later a clear “fracture line” can be seen again (C).
